Rimkus Consulting Group, Inc.
Eight Greenway Plaza, Suite 500
Houston, TX 77046
(800) 580-3228 Telephone
(713) 623-4357 Facsimile

Re: RCG File No: 11009971
LLV Number: 0209452
VMF Location: 1530 Greensmark Drive in Houston, Texas
Subject: Final Report

Rimkus Consulting Group, Inc. was retained to examine LLV 0209452, VIN 1GBCS10E4M2908832. The fire occurred on June 13, 2016 at around 12:30 P.M. the operator of the vehicle at the time of the fire, was unavailable for interview but reportedly stated the vehicle's engine died while delivering mail on his route and backfired during subsequent attempts to restart it. Soon thereafter, smoke was observed from beneath the hood as well as flames.

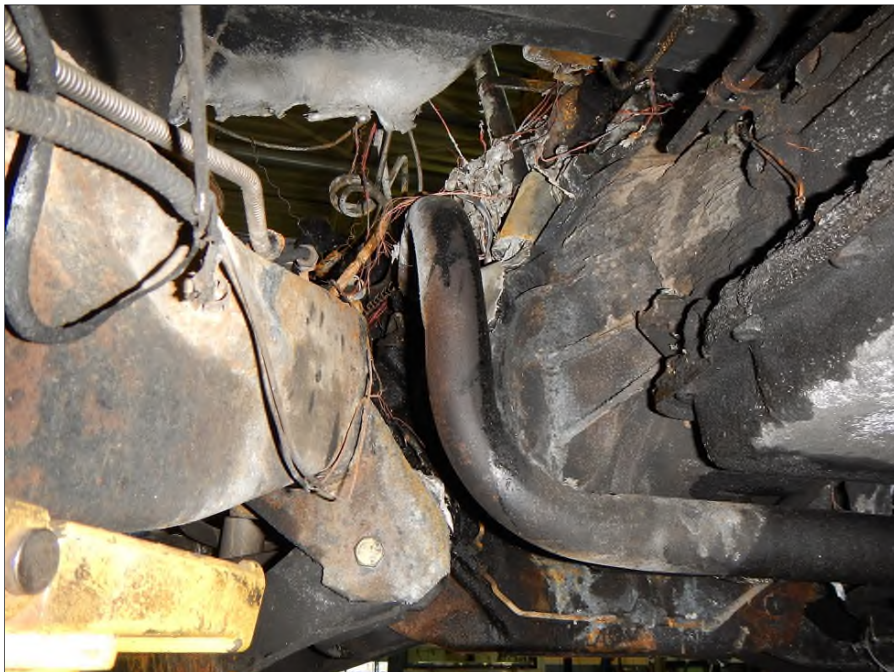
Photograph 8

3. The specific ignition sequence and cause of the fire was determined to be a direct result of leaking transmission fluid being ignited on the hot operating exhaust manifold within the engine compartment. Due to the severity of the fire damage, the exact location of the leak could not be conclusively determined.

Overview of the area of fire origin.

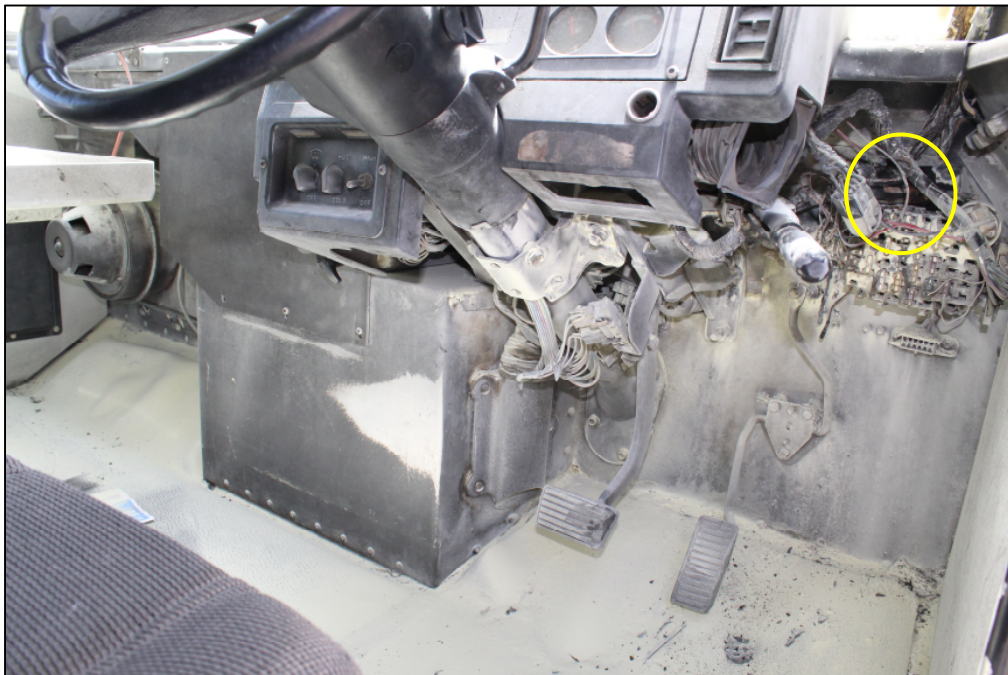
Photograph 2
Interior right side below dashboard. Origin area, yellow circle.

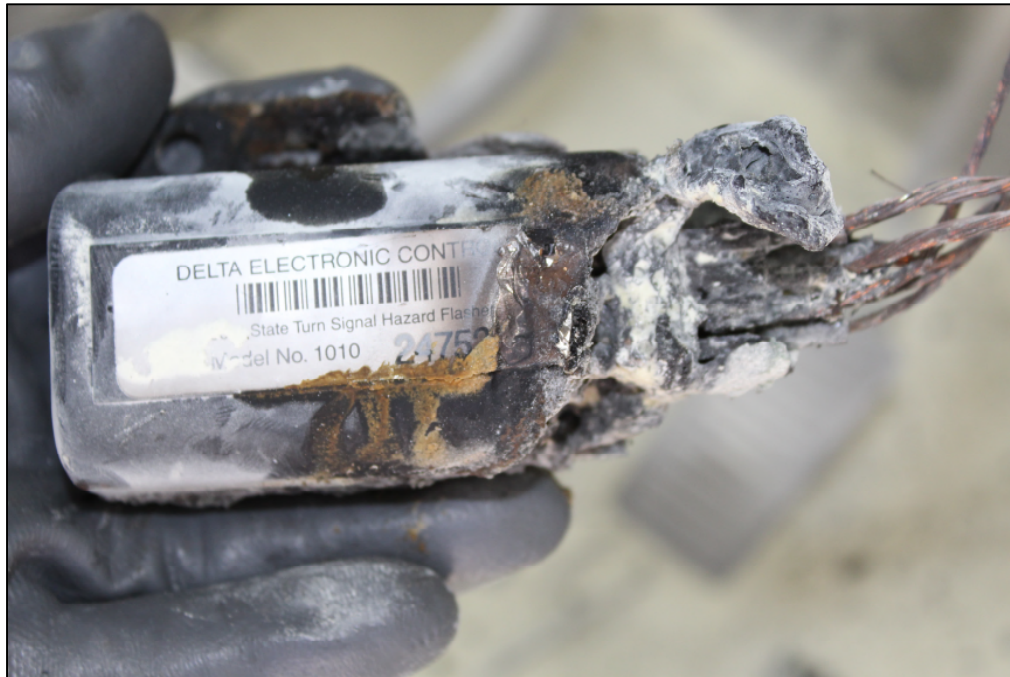
Photograph 3

Delta Electronic Control Solid State Turn Signal Hazard Flasher.

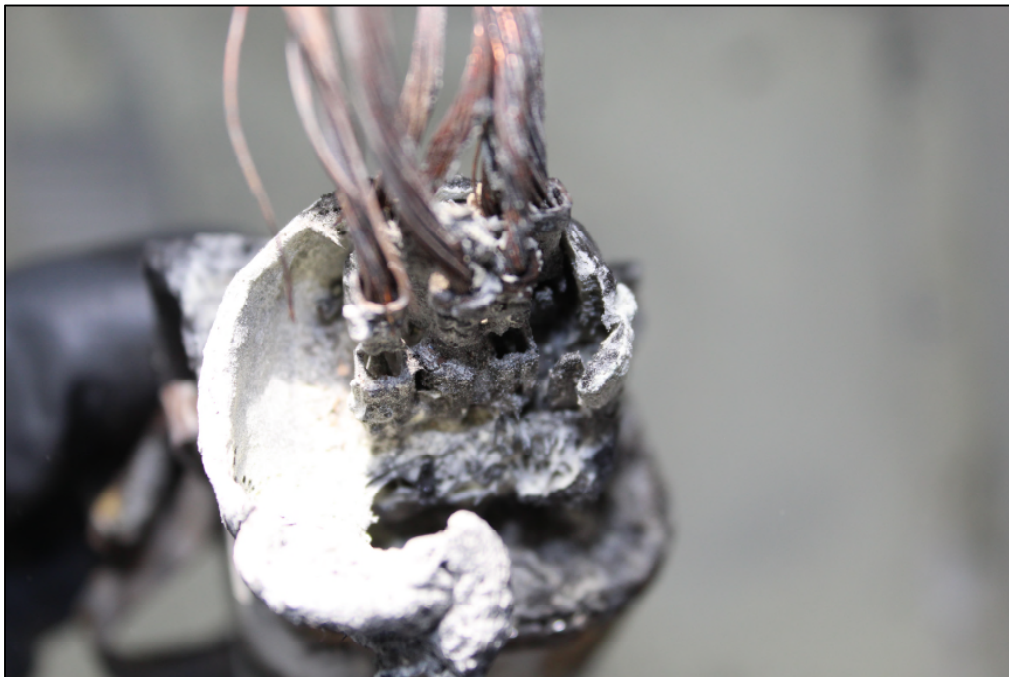
Photograph 4

Delta Electronic Control Solid State Turn Signal Hazard Flasher.

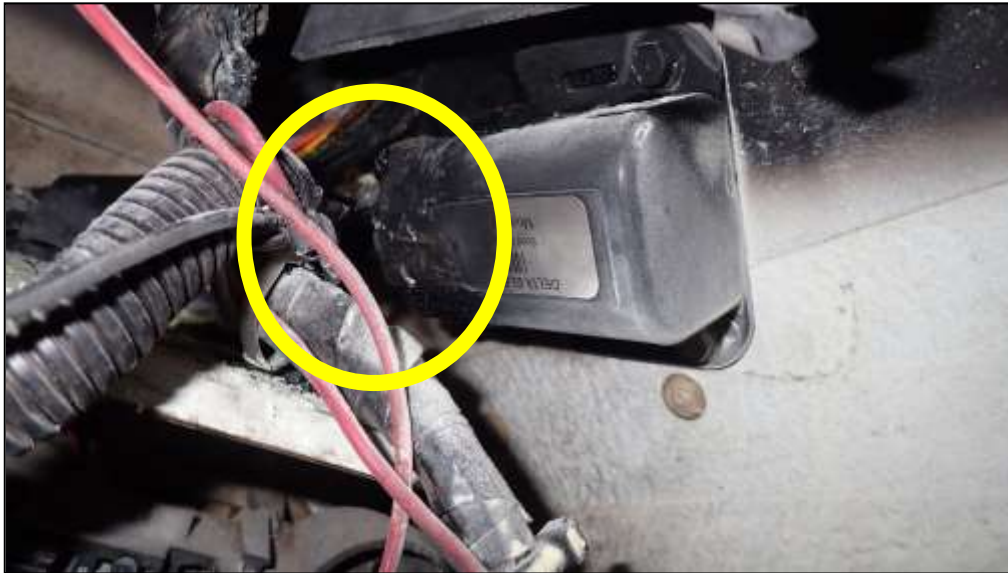
Photograph 4

View of the fire damaged emergency flasher override switch.

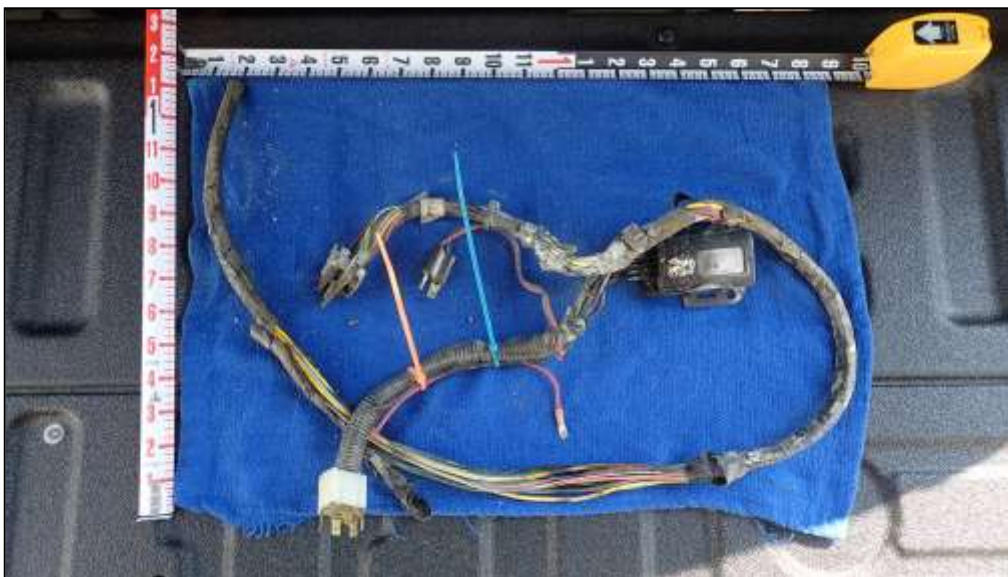
Photograph 5

View of the emergency flasher override switch and its associated wiring harness that was collected as evidence.

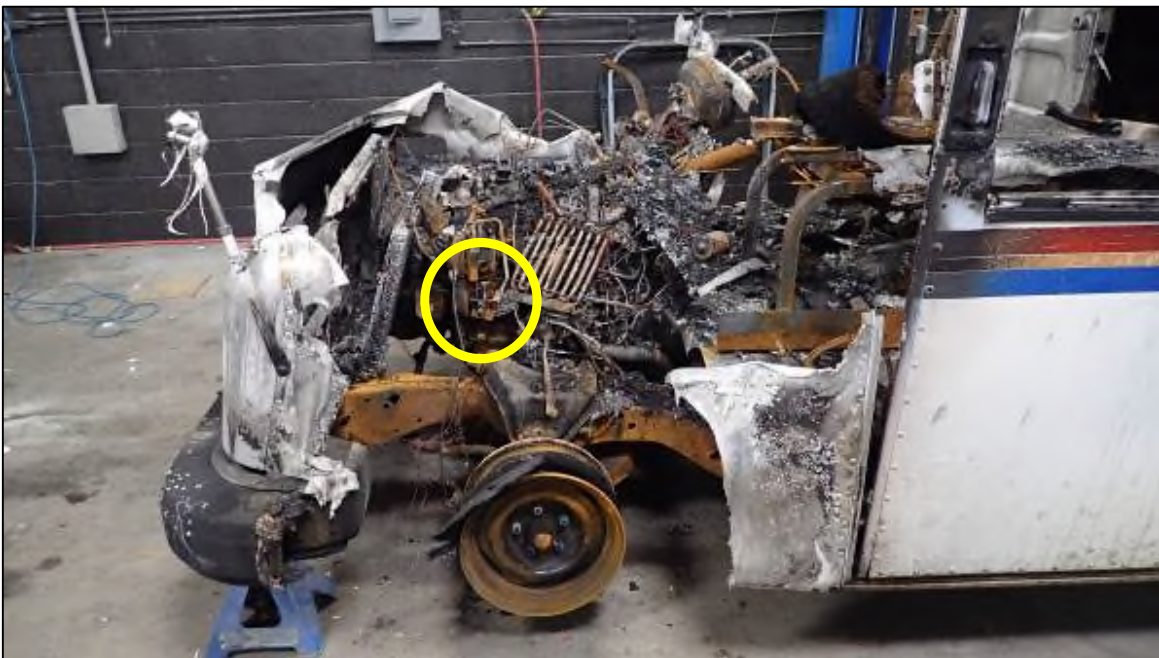
Photograph 2
View of the fire origin.

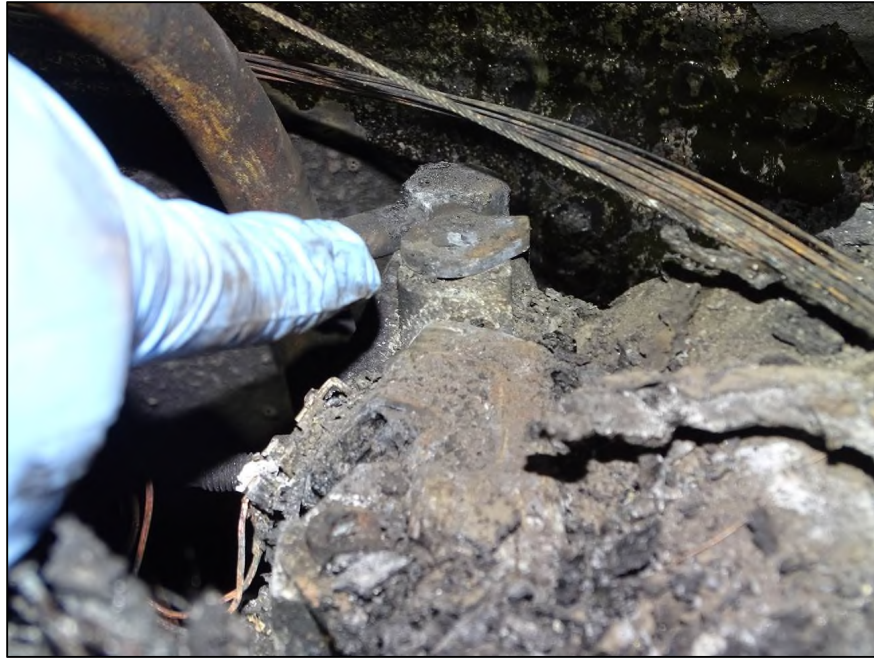
Photograph 3

Screw missing from retaining bracket.

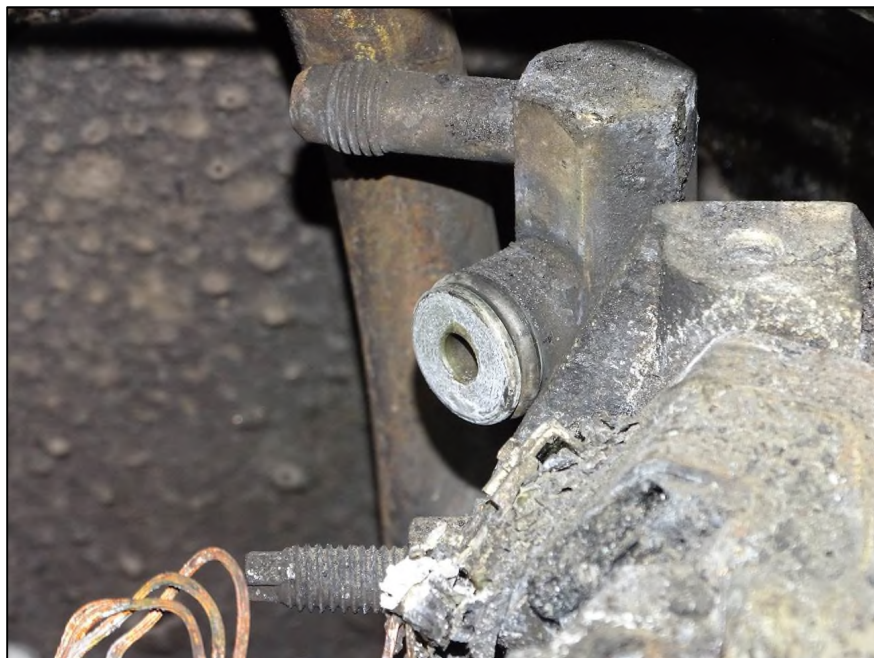
Photograph 4

Fuel line removed from fuel rail.

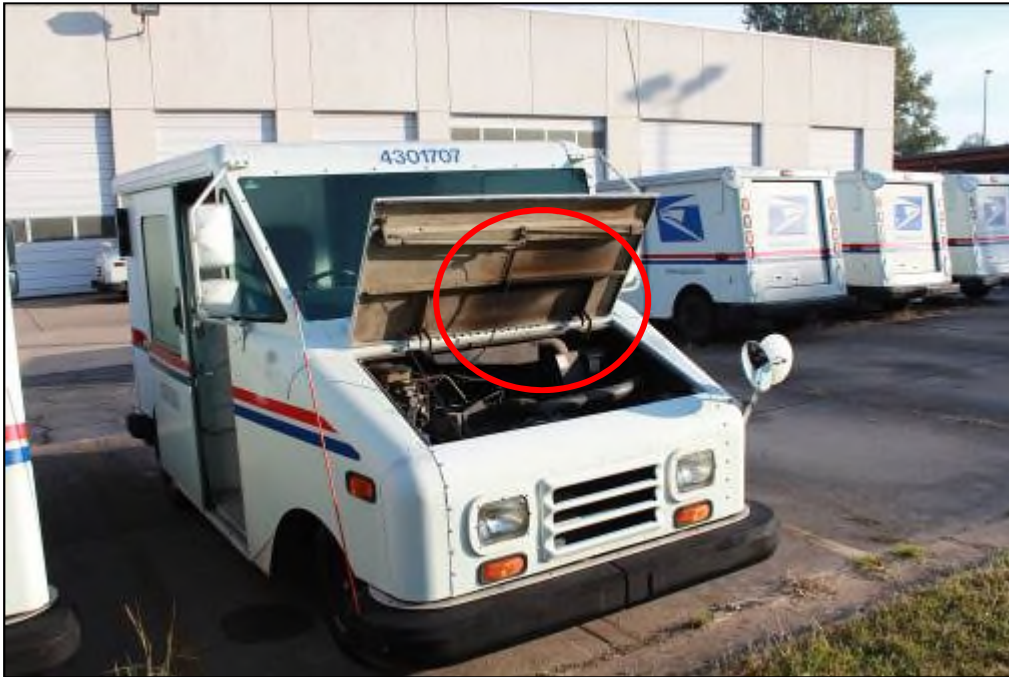
Photograph 1

Front side and right side showing fire patterns on the underside the hood.

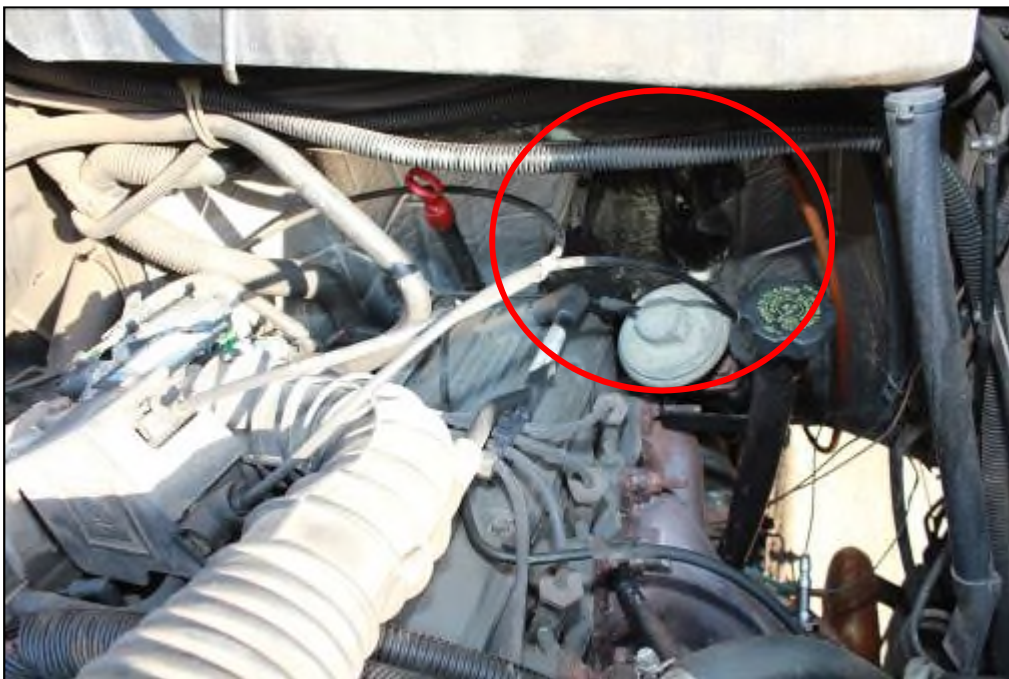
Photograph 2

Rear of the engine compartment showing fire patterns along the bulk head from below.

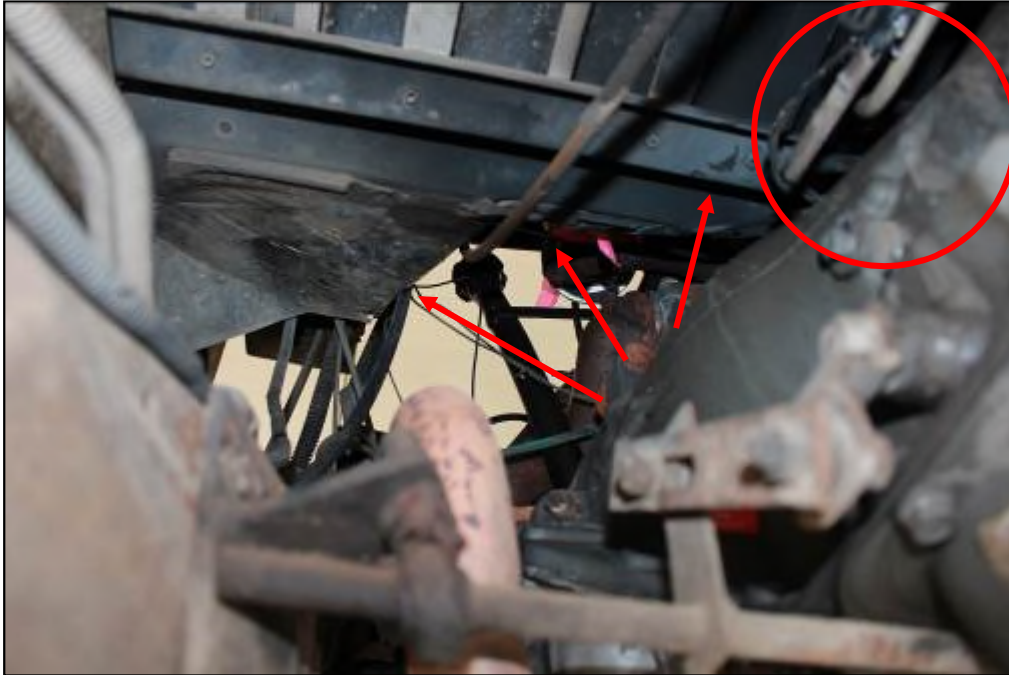
Photograph 3

From below the undercarriage looking up on the left side of the transmission showing the fuel lines and the fire patterns from above the transmission into the engine compartment.

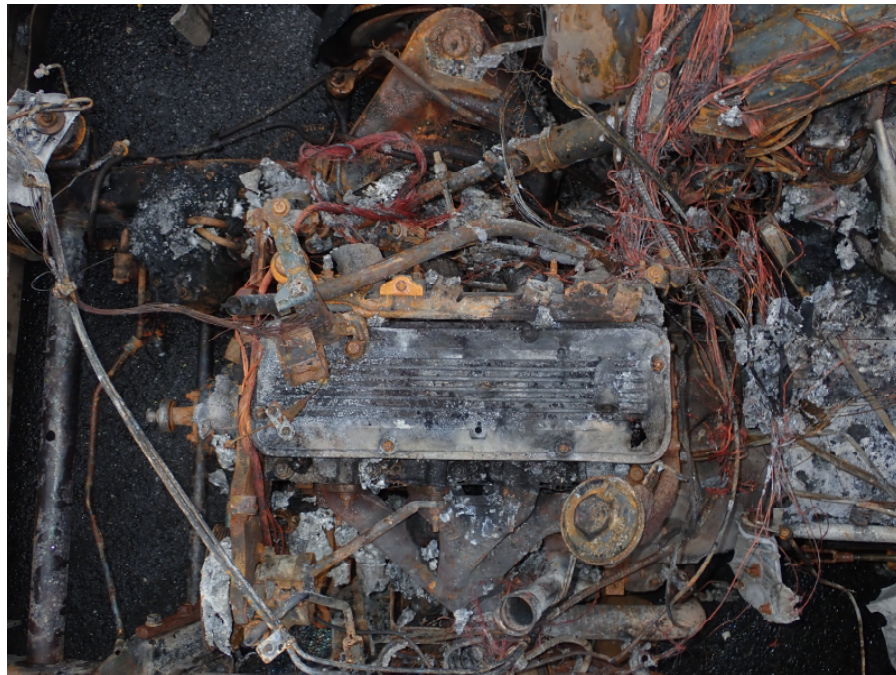
Photograph 4

Close-up of engine.

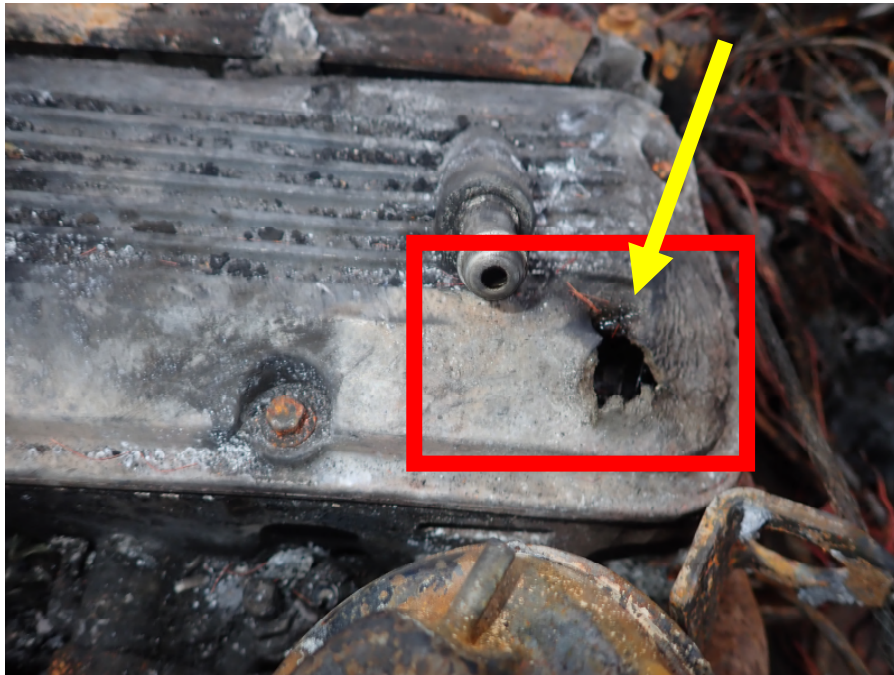
Photograph 5

Close-up of engine compartment.

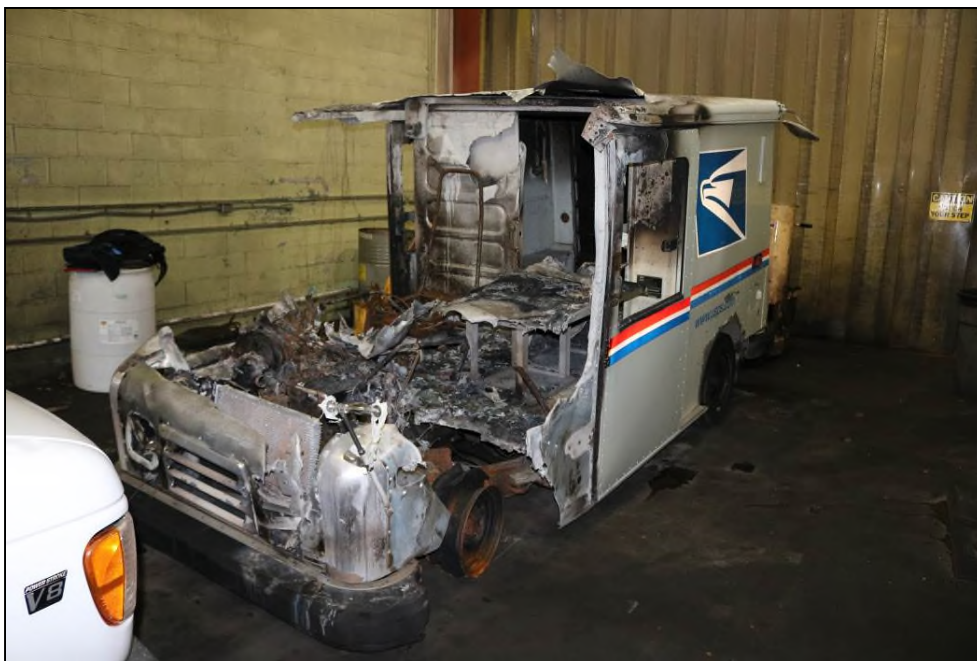
Photograph 1

The vehicle sustained severe fire damage to the engine and mail compartments. Based on the fire patterns observed, it was determined the fire initiated within the engine compartment then progressed into the mail compartment through the windshield and bulkhead. Fire development patterns were observed on the rear sides of the vehicle indicating fire communication from the front mail compartment into the rear cargo area along both sides of the vehicle.

Frontal view of vehicle – mail side.

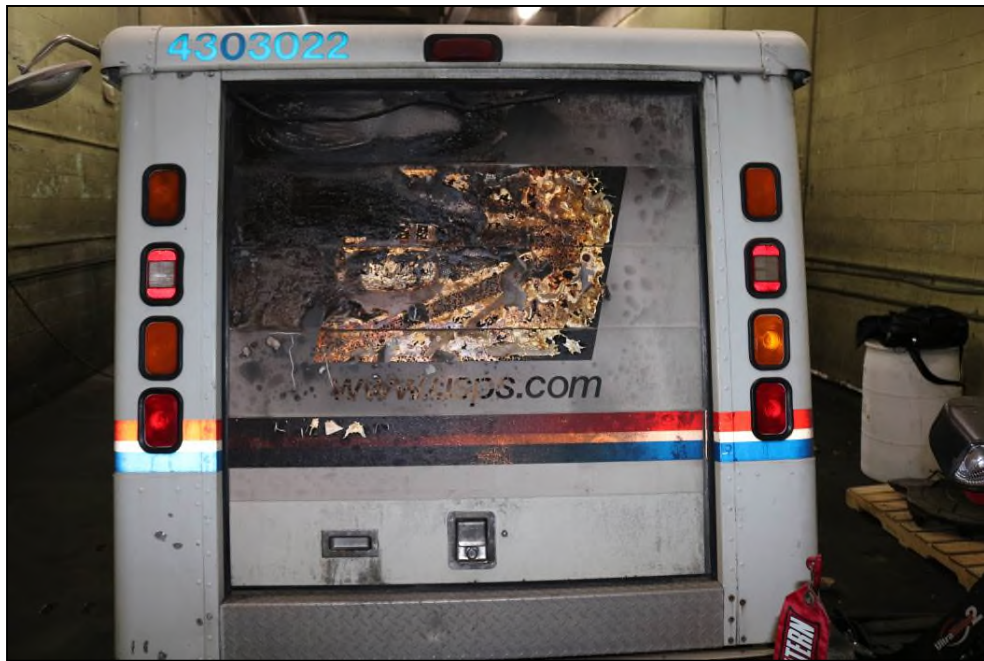
Photograph 3

The rear cargo door sustained moderate fire damage to the exterior from fire development inside the rear cargo area.

Rear view of vehicle.

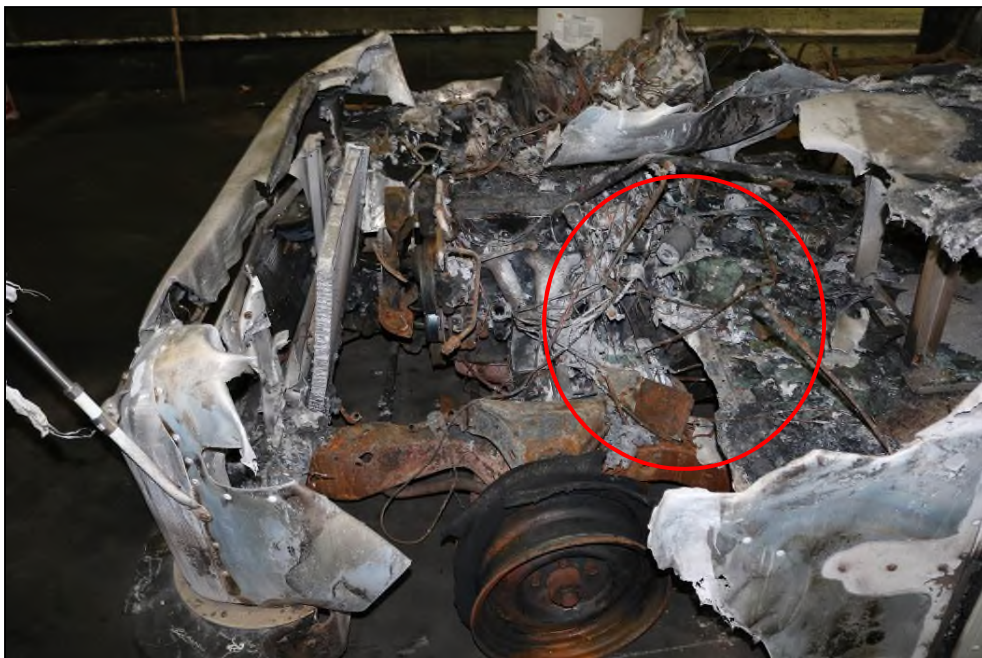
Photograph 4

The engine compartment sustained severe fire damage and mass loss. Based on the fire patterns and mass loss observed, it was determined that the fire origin was located on the mail side, rear area of the engine compartment near the bulkhead.

The fire originated within the engine compartment, on the bulkhead near wiring and the heater components. The heater components sustained the most severe oxidation and fire damage. The heater fan was not frozen. The conductors leading away from the fan were separated from their ends. One of the multi-stranded conductors had adverse electrical activity (welding of the multi-stranded conductors).

- He stated he opened the hood and found a fire along the "firewall" where three wires were running. He didn't see fire anywhere else. He attempted to extinguish the fire with a fire extinguisher provided by a citizen.

Area of origin of fire.

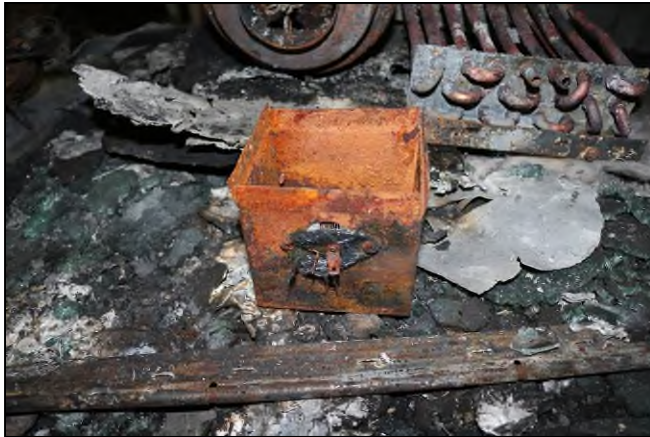
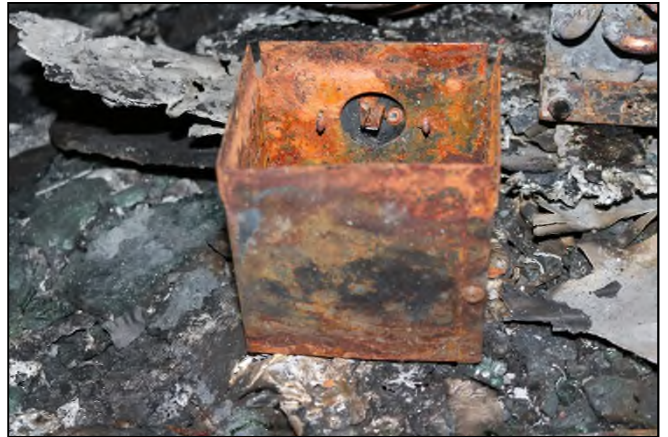
Photograph 5

Severe oxidation of heating components.

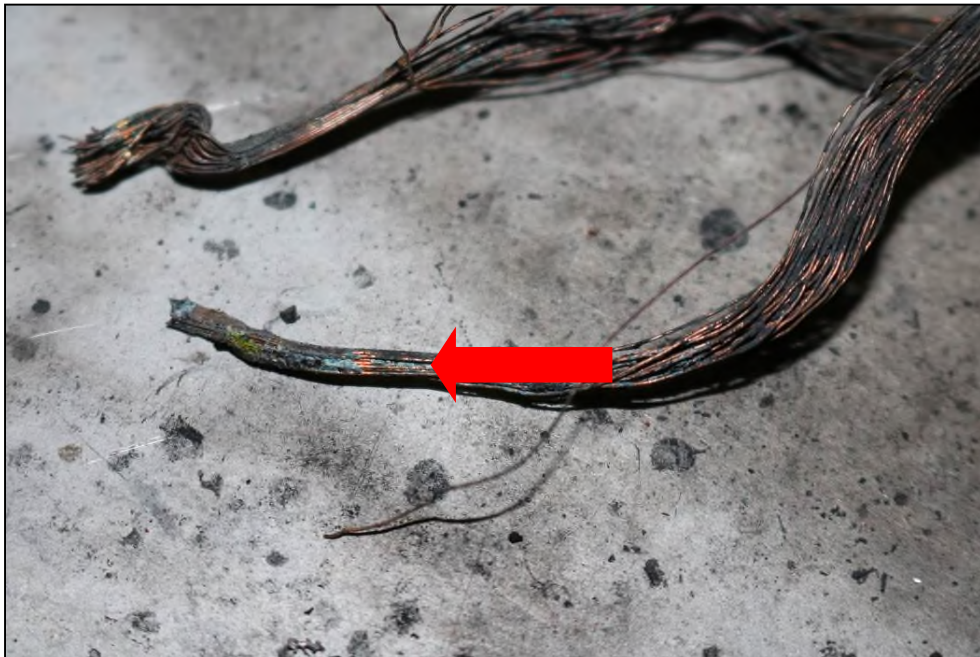
Photograph 6

Adverse electrical activity on wiring of heater blower motor.

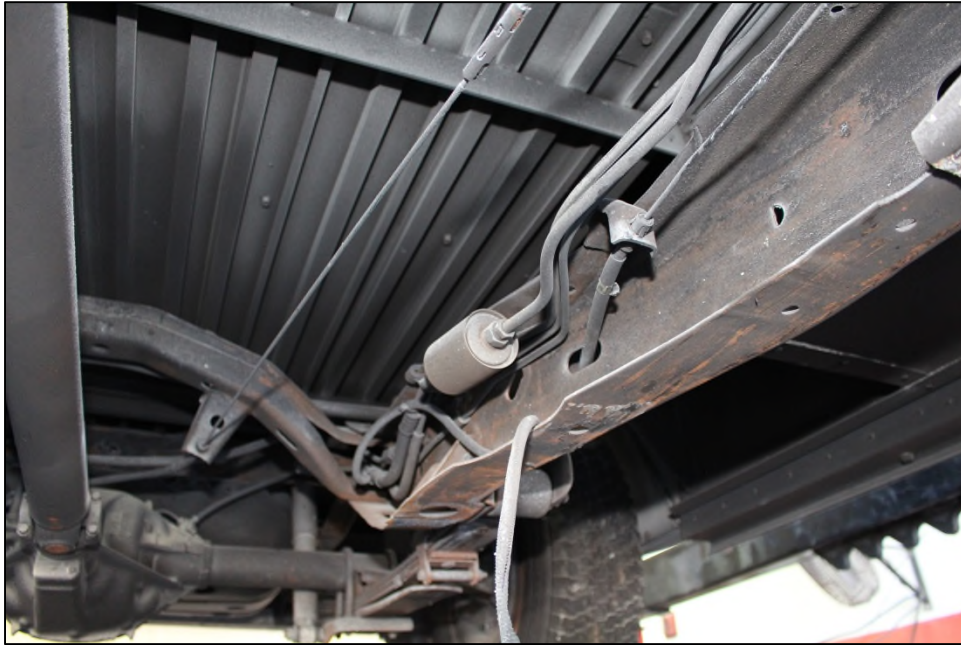
Photograph 3

The fuel filter was positioned on the left side of the undercarriage along the frame.

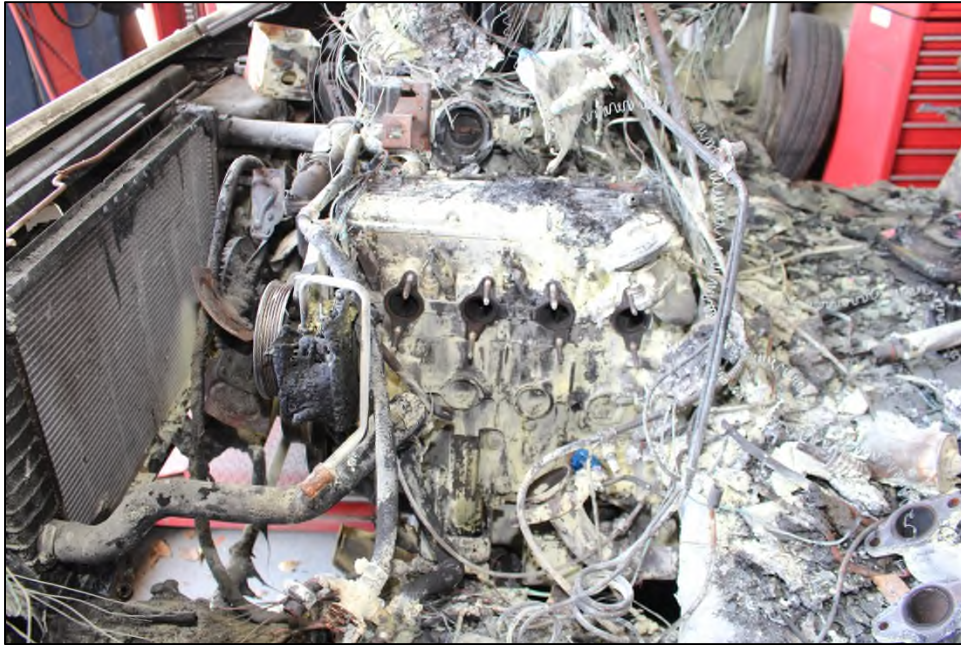
Photograph 5

View of the engine block after the exhaust manifold was removed.

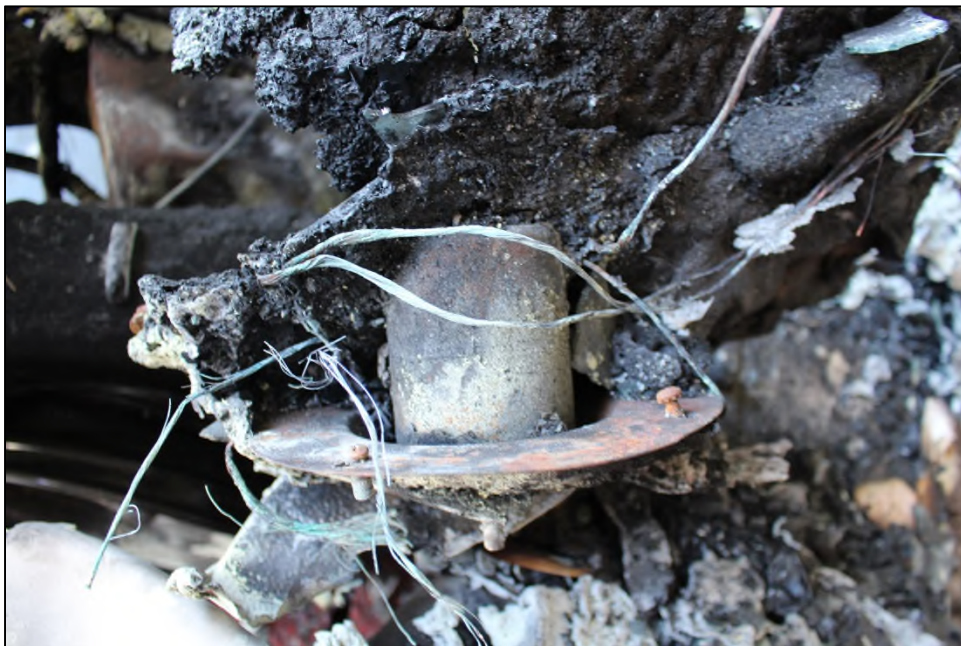
Photograph 6

View of the blower motor/fan assembly.

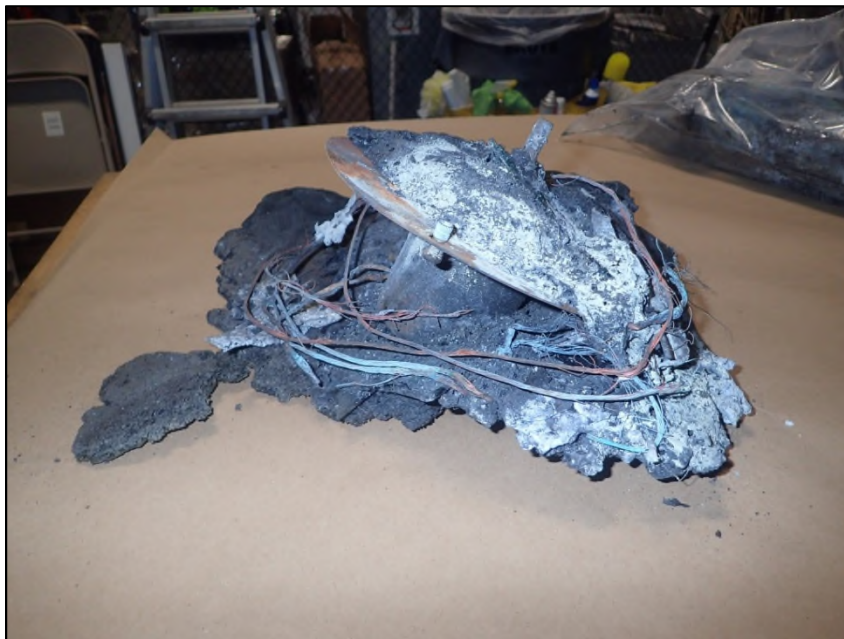
Photograph 7

View of the blower motor/fan assembly.

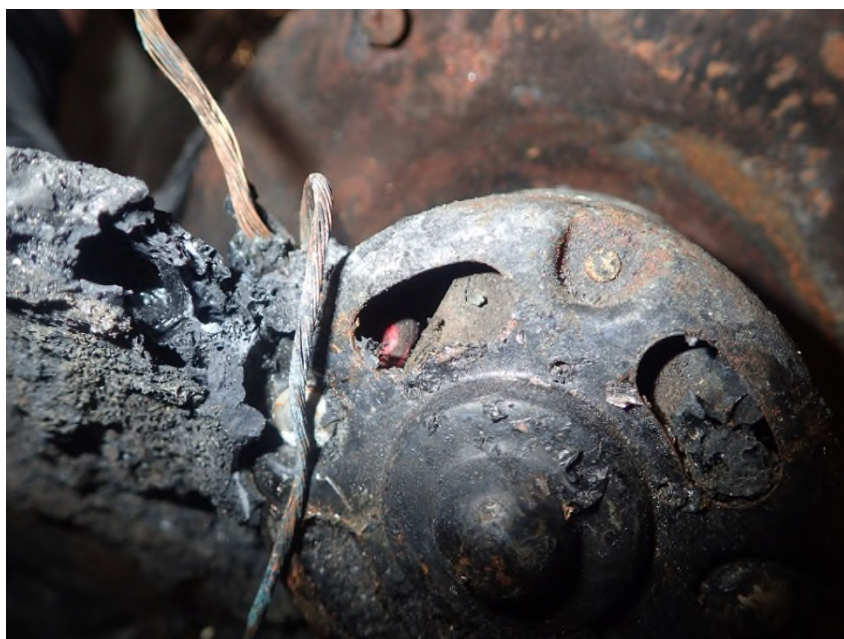
Photograph 8

Close up view of the blower motor/fan assembly.

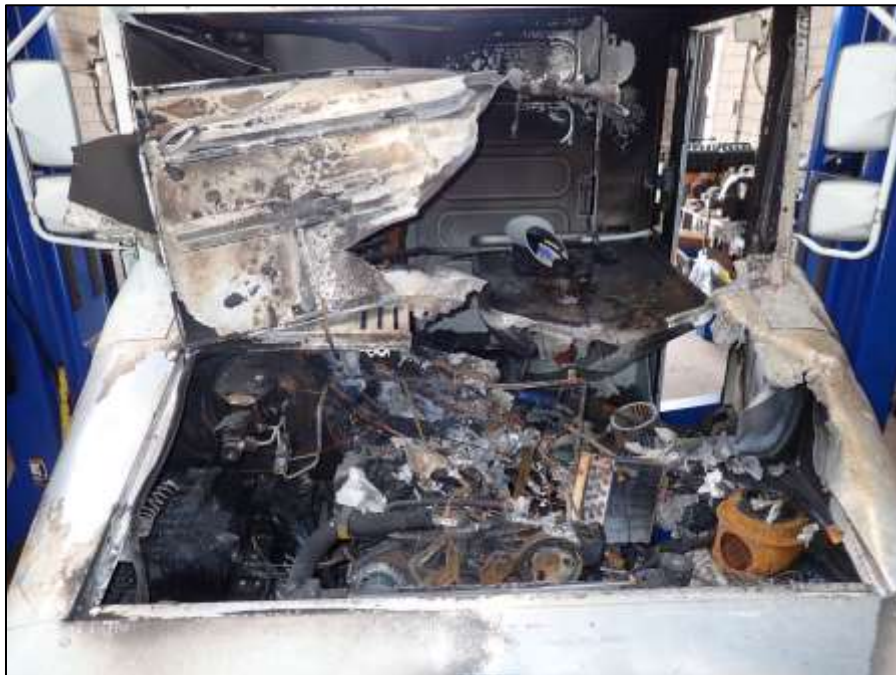
Photograph 2

Overall view of engine compartment.

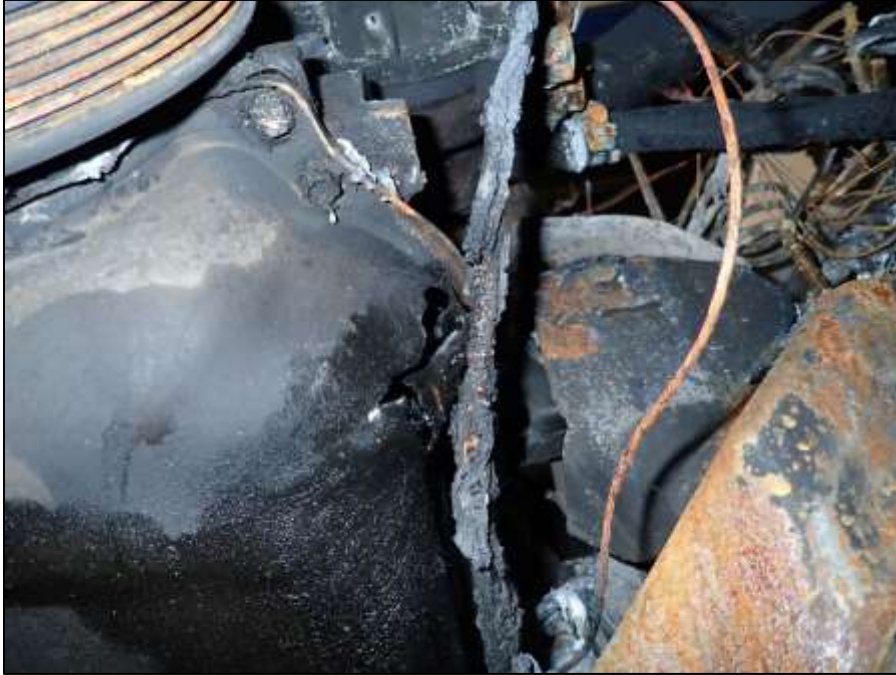
Photograph 3

Positive cable arced to oil pan.

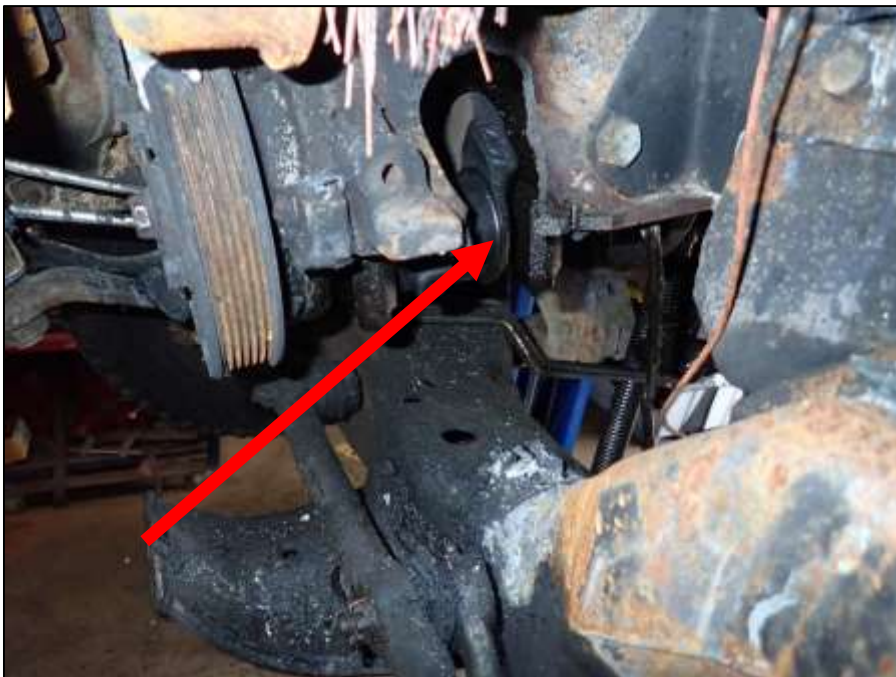
Photograph 4

Hole in engine block.

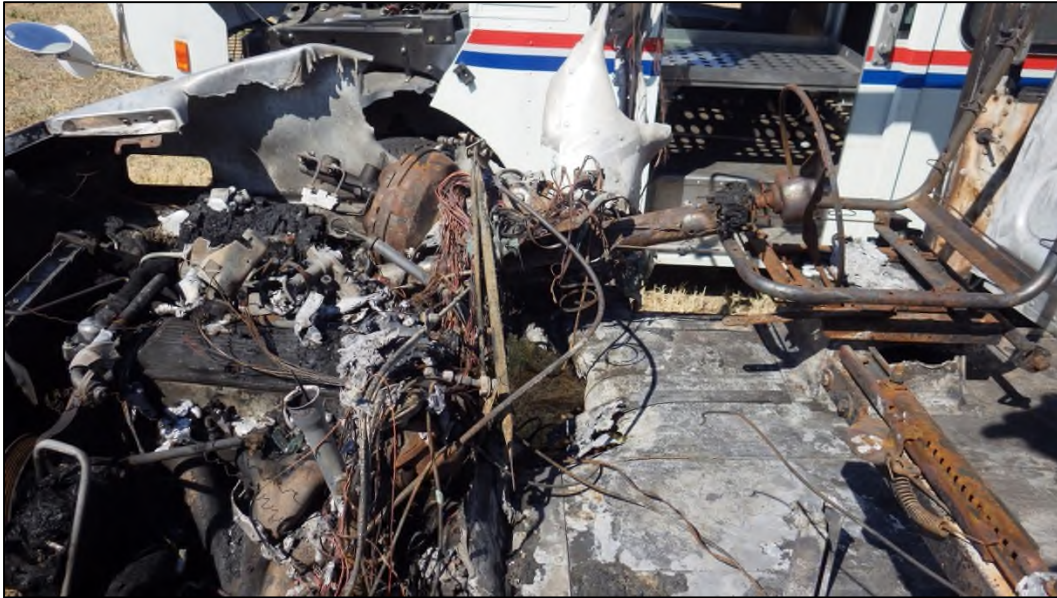
Dash and Bulkhead area of LLV.

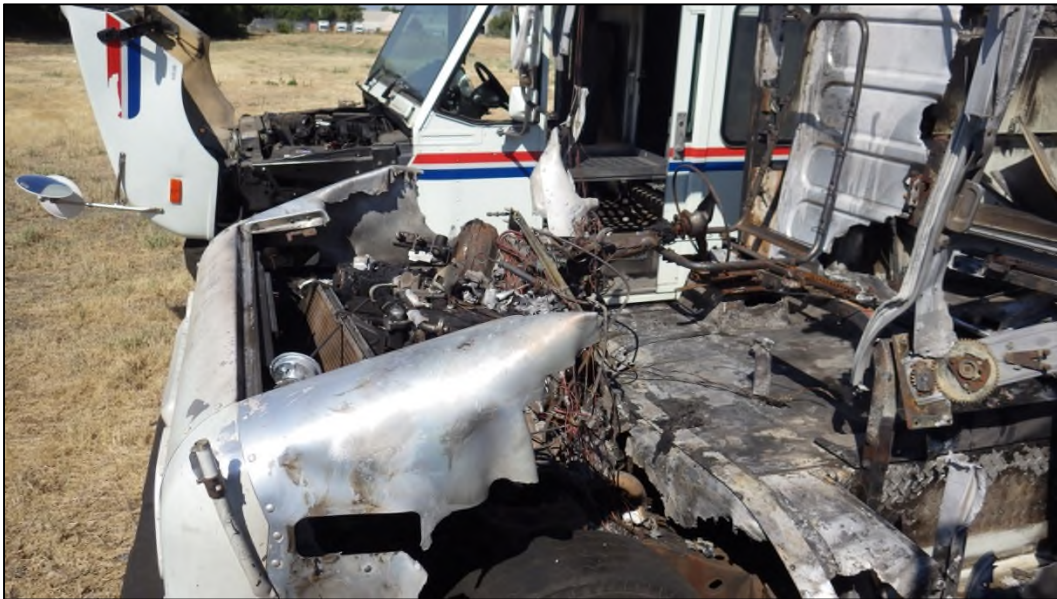
Photograph 4

Area of origin in LLV.

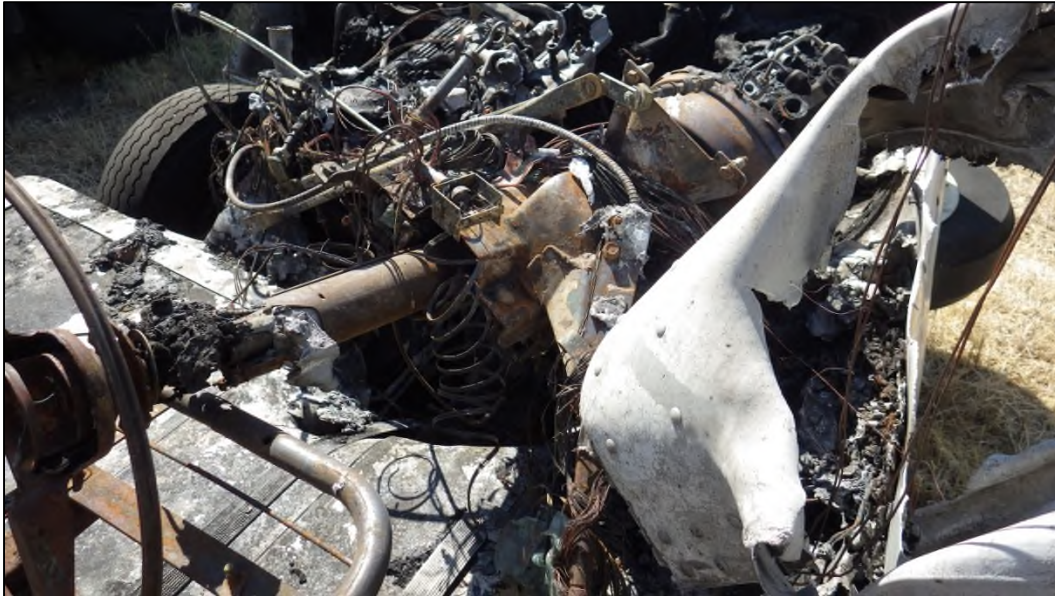
Photograph 5
Steering column area of LLV.

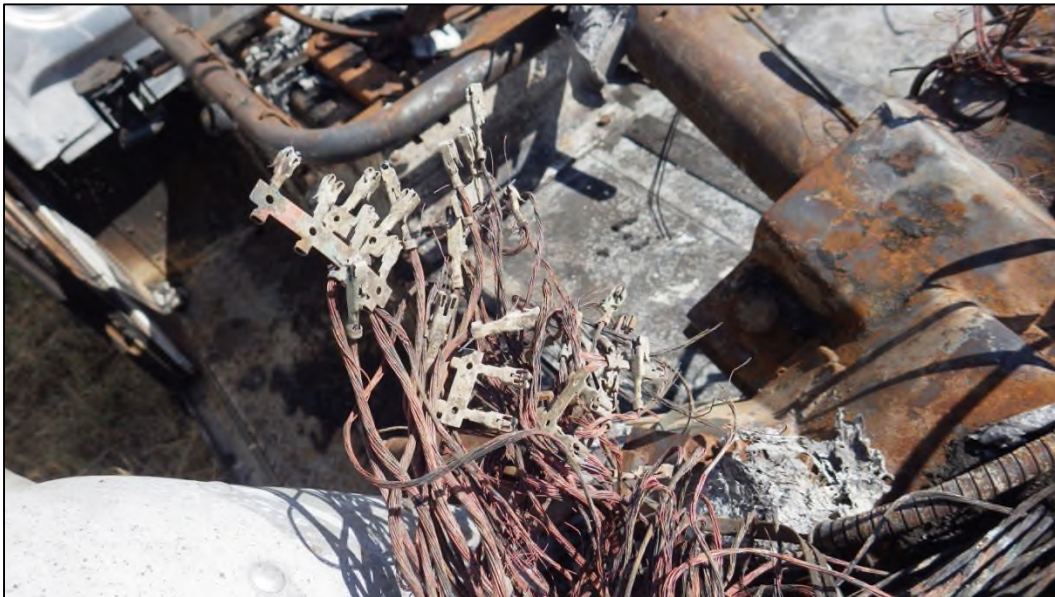
Photograph 6
Fuse panel area of LLV.

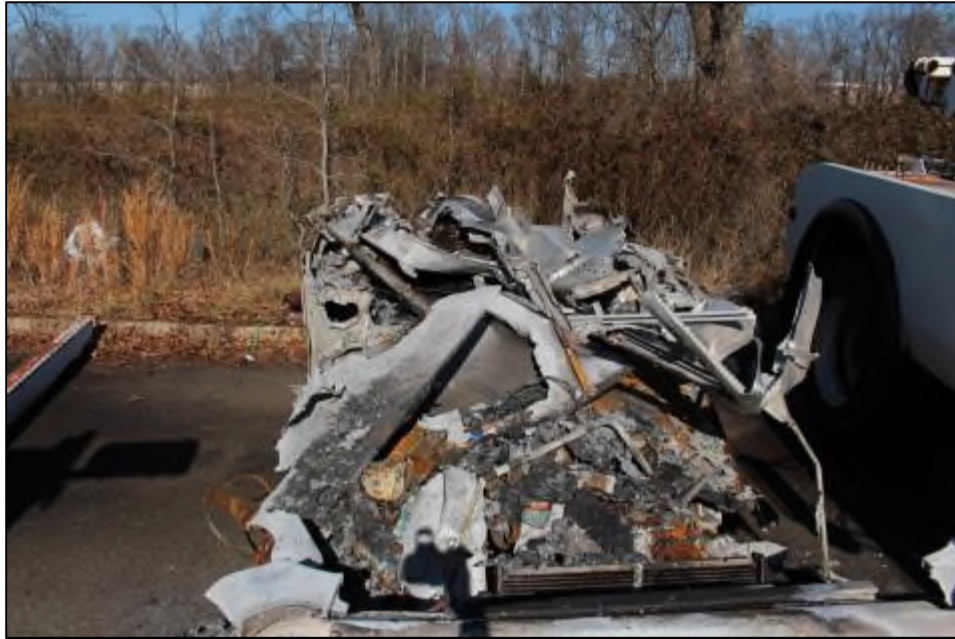
Photograph 5

Overall of vehicle remains.

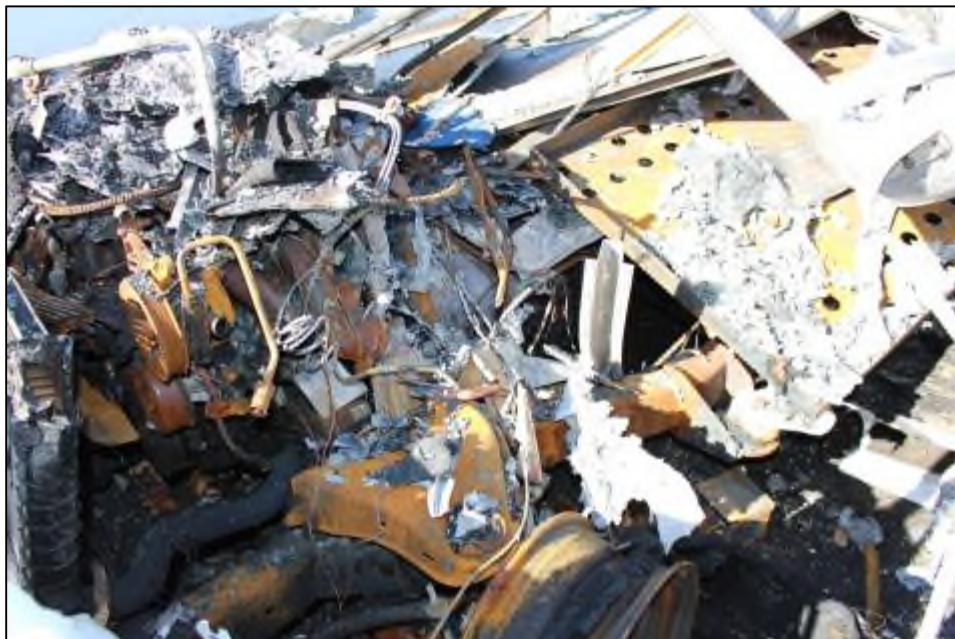
Photograph 8

Engine compartment.

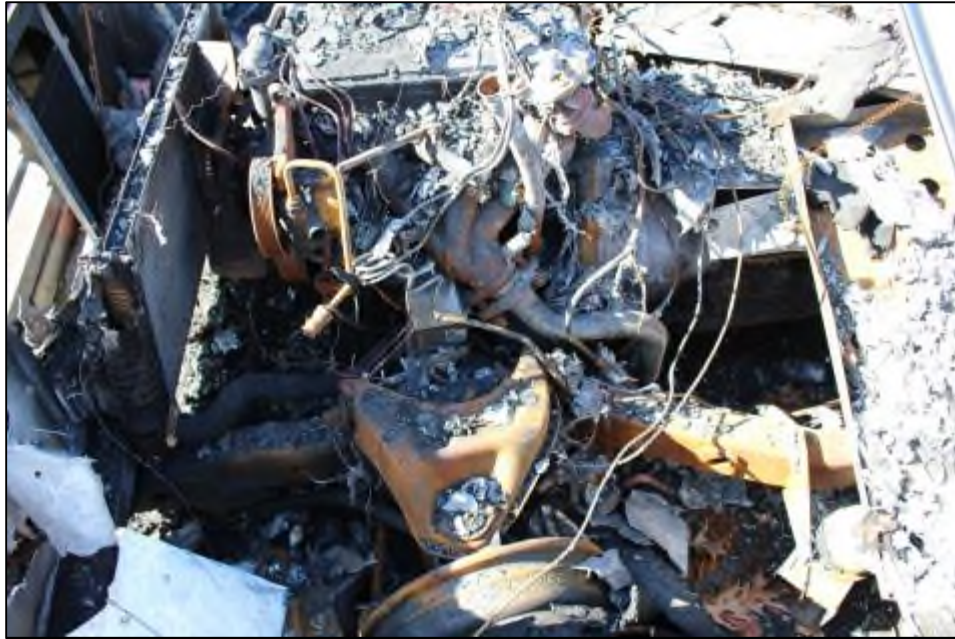
Photograph 9

Engine compartment from left side.

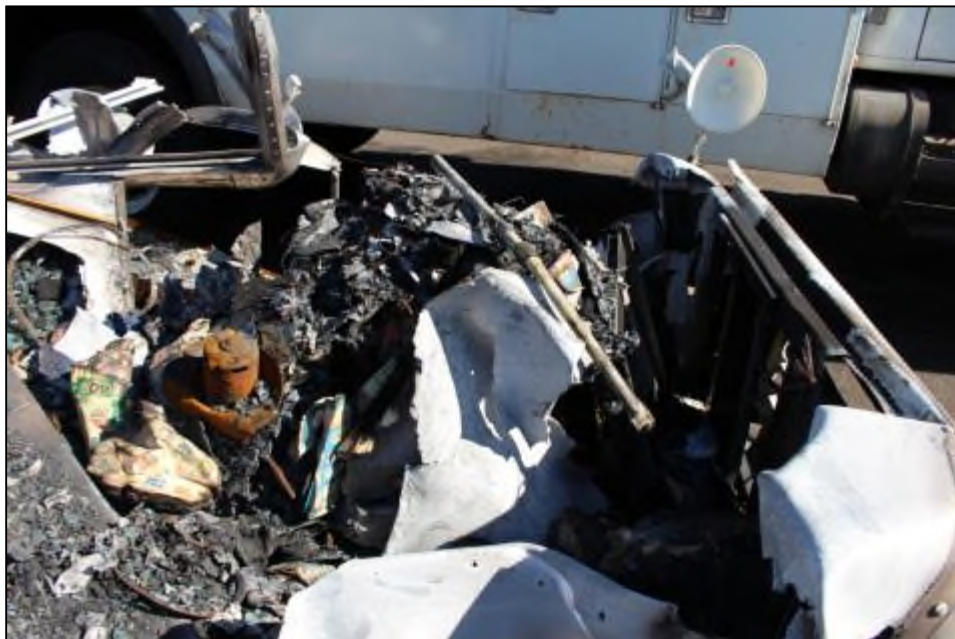
Photograph 10

Engine compartment from right side.
